Service Bulletin

REFRIGERATORS
20' AND 22' BOTTOM FREEZERS

REF 01-08

ICE CLUMPED IN ICE BUCKET AND ON FREEZER FLOOR

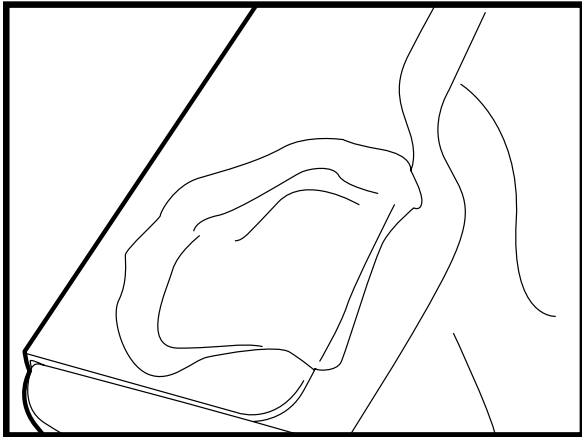
On the above mentioned 20' and 22' bottom freezer refrigerators there have been consumer concerns regarding clumped cubes in the ice bucket, an ice sheet on the rear of the ice bucket or on the freezer floor and, in some cases, ice forming on the freezer drawer slides. In order to rectify this situation the fill cup extension (Service Part Number **WR29X10078**) should be installed.

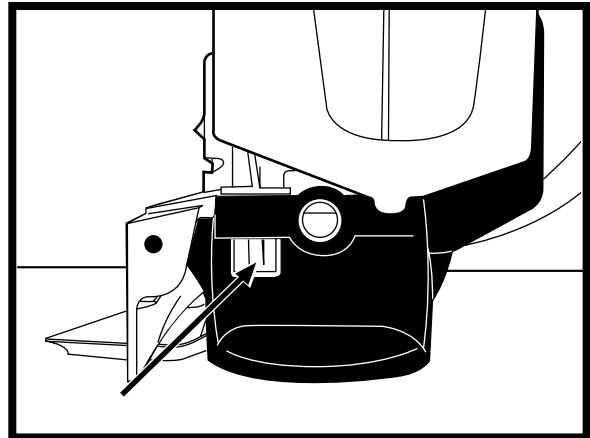
Figure 1-Locking tab on fill cup

1. Remove the fill cup, mounted to the rear of the ice maker, by depressing the locking tab at the rear of the icemaker mold body, lifting the fill cup up, away from the icemaker.

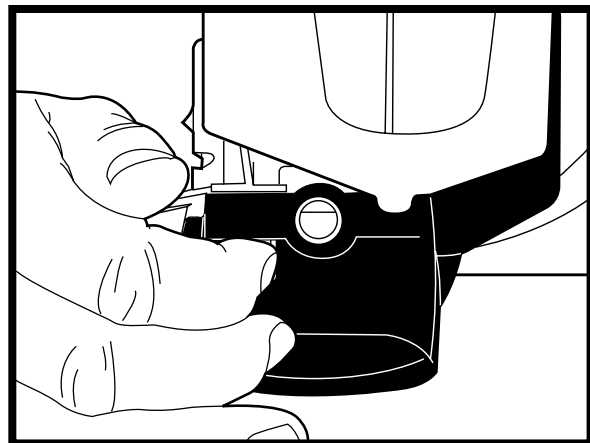
Figure 2-Depress locking tab on fill cup

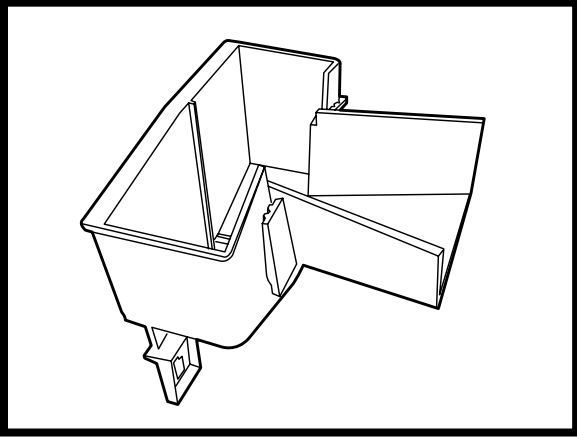
Figure 3-Fill cup with extension installed

2. Attach the fill cup extension (service part number **WR29X10078**) to the fill cup by sliding the extension onto the rear of the fill cup. Ensure the extension is pushed fully into the slot on the fill cup as shown in Figure 1.

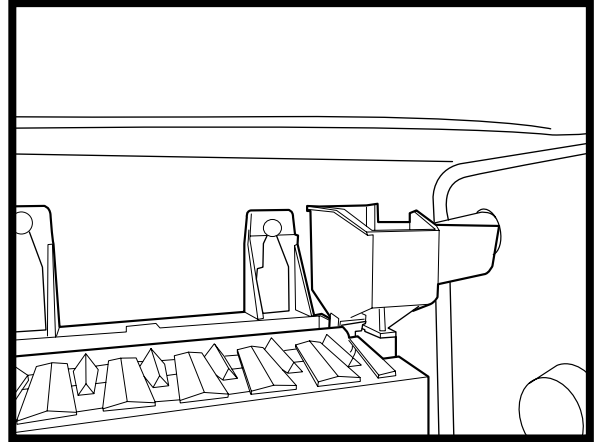
Figure 5-Fill cup with extension installed

3. Re-attach the fill cup, with extension, to the ice maker. Ensure that the fill tube is properly aligned with the fill cup, and the fill cup is properly attached to the icemaker.

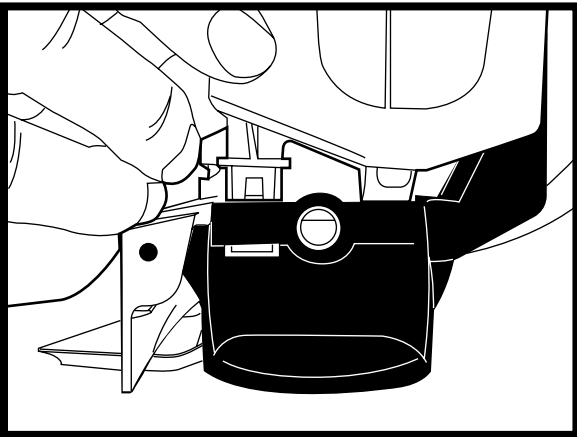
Figure 4-Lift up the cup

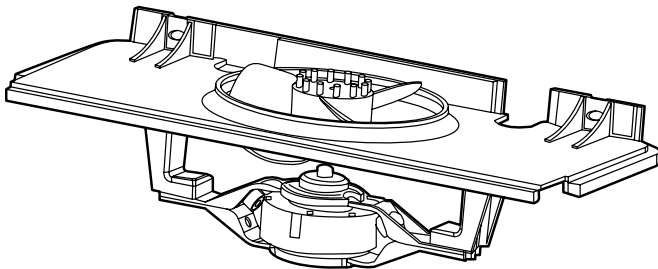
Fig 1

You may find an ORIFICE FAN ASSEMBLY (Fig. 1) instead of the Orifice Fan referenced in IPC (Fig. 2), this change is made to address a noise issue.

Install "ORIFICE FAN ASSEMBLY KIT", **WR49X10190**. This will alleviate the evaporator fan noise.

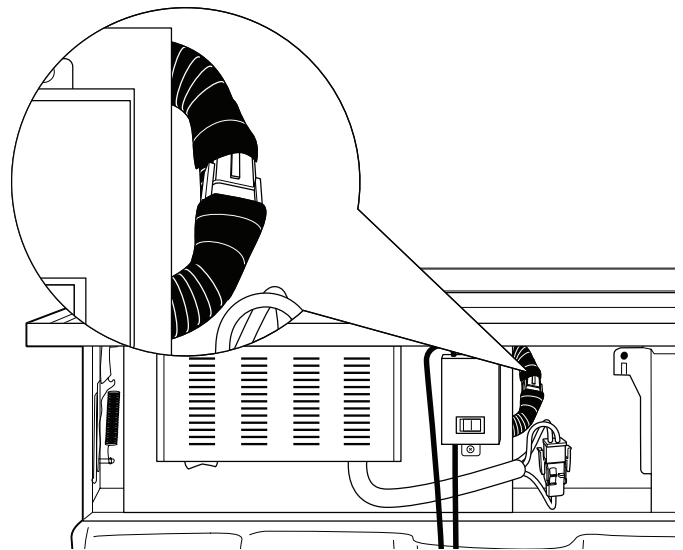
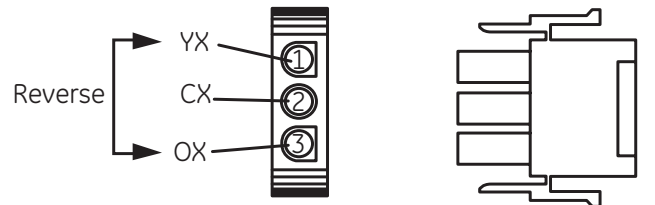
2008 Monogram side-by-side refrigerators may have reversed wires on the AC harness connections to the Sabbath Kit. The reversed wires will cause a tripped circuit breaker or blown house fuse when the Sabbath switch is turned on. Turning off the Sabbath switch will allow the refrigerator to function until the incorrect wiring can be repaired. The harness connections can be repaired by moving 3 pins in the connectors.

- Locate the Sabbath Connectors on the AC harness behind the water filter.
- Remove the tape and disconnect the connector.
- Reverse the yellow wire and the orange wire in the male connector. The connector pin diameter is 0.084. A pin extractor tool such as the AMP 1-804030-1 can be used.
- Move the yellow wire in the female connector to the empty pin location.

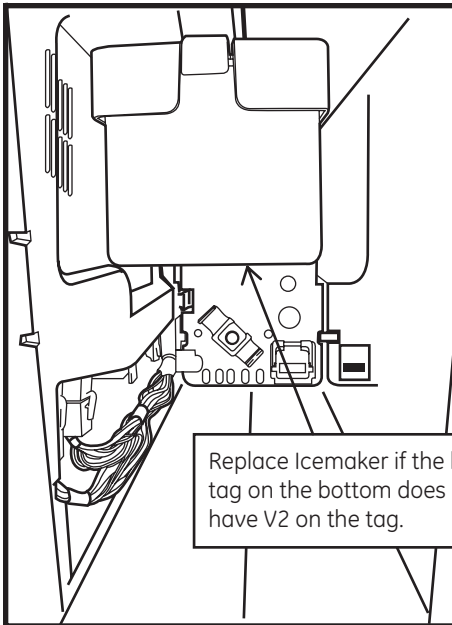
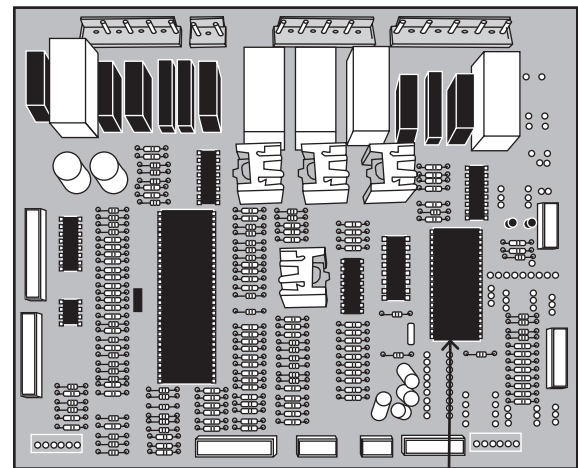
PBA Main Best

When the icemaker dumps ice cubes to the ice bucket, ice cubes jam between the icemaker and the liner. The icemaker makes a loud noise and eventually stops working.

Replace icemaker kit and main PCB. Parts code remains unchanged.

Replace main board if software version is lower than 4.02 on left processor.
