GE Consumer & Industrial Service Bulletin

SEPTEMBER 2009

REFRIGERATOR
CENTER HINGE

REF 14-09

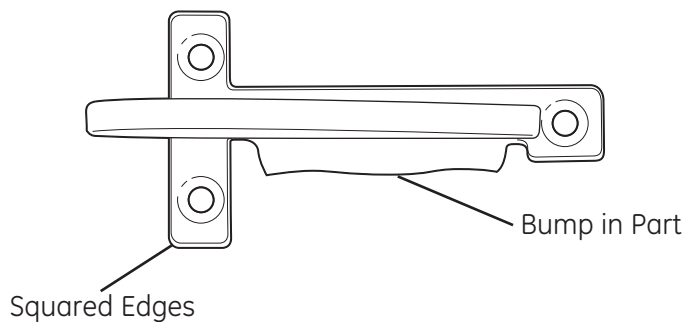
CURRENT PART: WR13X10317

On some Stainless Steel units, reversal of the door swing from RH to LH will result in interference of the fresh food door end cap with the center hinge. In some cases, this will prevent the door from opening completely.

Note squared edges and bump in part on current part versus replacement part.

Replace current center hinge with new part, WR13X10144.
