**GE Appliances**

## Service Bulletin

REFRIGERATOR-FREEZER REF 05-00 SXS-24, 28 & 30 CU. FT. MODELS FOOD FREEZING ON TOP FRESH FOOD SHELF

**MAY 2000**

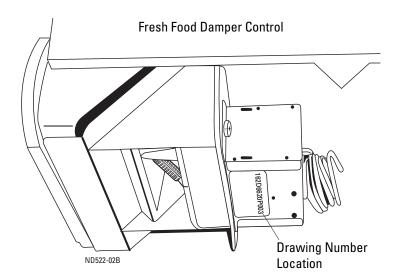
Figure 1

- Remove the Temperature Control/Light Shield to expose the fresh food damper control.
- 2. The fresh food damper control installed in the refrigerator should have the identifying drawing number **162D6620P003** (Figure 1). If the damper control is identified by any other number, remove that damper control and replace with damper control **WR9X10002**.
