# Service Bulletin

## REFRIGERATION ALL TOP-FREEZER NO-FROST MODELS, MANUFACTURED BETWEEN SEPTEMBER 2003 AND MARCH 2004 EXCESSIVE REFRIGERATOR NOISE

REF 06-04

APRIL 2004

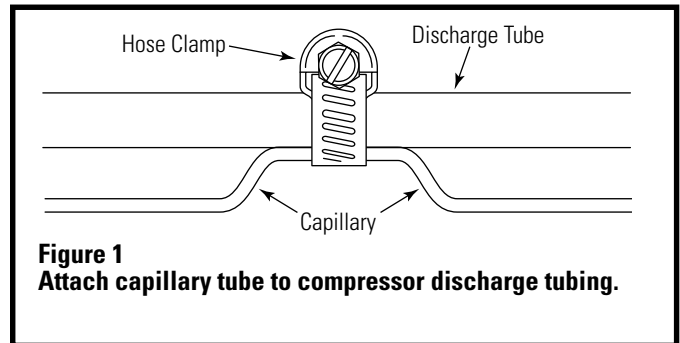
Refrigerator design changes, implemented to comply with energy efficiency requirements, have resulted in most consumers experiencing refrigerant noise to some degree. This noise is described as a low, pulsating, intermittent sound. It is caused by a combination of less refrigerant and a more efficient way of moving refrigerant through the system. The sound occurs more frequently during the defrost cycle and during door openings. New designs in home construction and remodeling can also impact the amount of noise heard. Hardwood, slate and tile flooring provide little or no sound absorption, this, coupled with an open floor plan make operating sounds more noticeable.

When installing the drier and recharging the unit, make certain that the capillary tube is attached to the compressor discharge tubing with a hose clamp (WR2X4754). See Figure 1.
