GE Consumer & Industrial

# Service Bulletin

REFRIGERATORS REF 07-04  
TOP-FREEZER 18 AND 19 CU. FT. MODELS,  
MANUFACTURED SINCE FEBRUARY 2001  
POOR EVAPORATOR AIRFLOW

MAY 2004

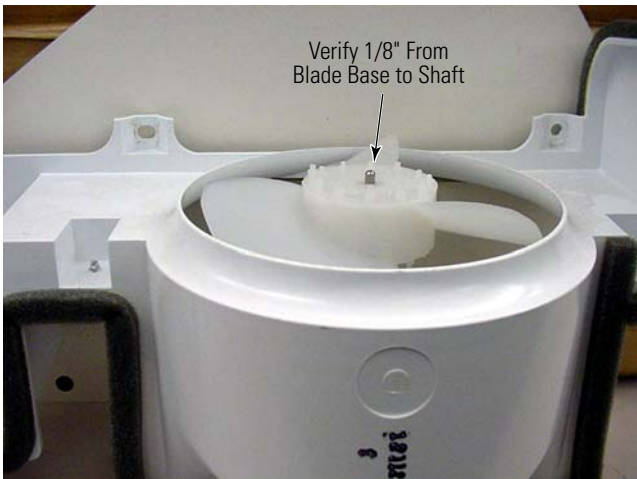
Insufficient cooling can be the result of the evaporator fan blade positioned improperly on the motor shaft, resulting in poor evaporator airflow.

Figure 1 Verify measurement of 1/8" from blade base to shaft

Place the evaporator motor blade on the shaft. Measure with a standard ruler. Make certain **1/8"** of the shaft is exposed. See Figure 1.

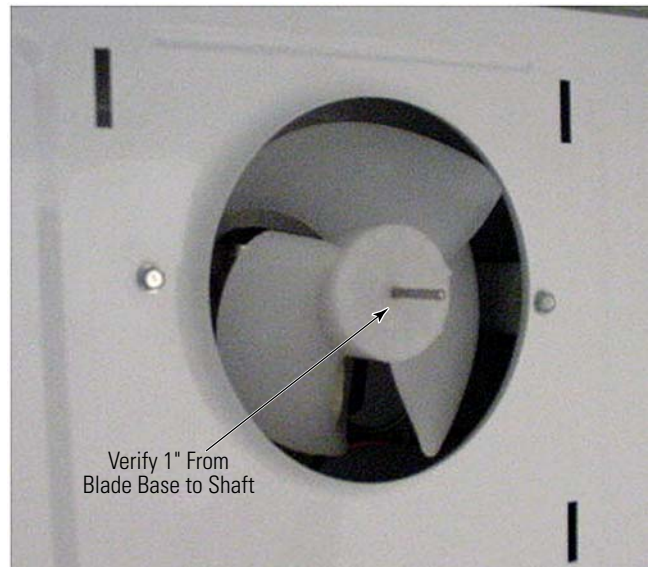
Figure 2 Verify measurement of 1" from blade base to shaft

**For units manufactured after March 2003:**  
Place the evaporator motor blade on the shaft. Measure with a standard ruler. Make certain **1"** of the shaft is exposed. See Figure 2.
