Service Bulletin

GE MONOGRAM REFRIGERATORS
MAY 1995 TO CURRENT
CRACKED WATER TUBING

REF 10-00

JUNE 2000

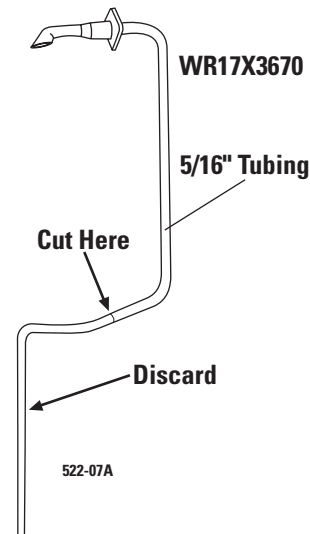
Fig. 1

CRACKED WATER TUBING AT THE RECESS FLANGE

If Monogram refrigerator has water leaking from the bottom of the freezer door. The leak is likely to be caused by cracked tubing. The tubing is cracked at the recess flange behind the dispenser.

The repair can be accomplished with the use of a grommet and tube assembly **WR17X3670** (5/16" tubing) with **WR2X9286** or **WR02X10444** reducing connectors (5/16" to 1/4").

1. Remove recess
2. Cut **WR17X3670** grommet and tube assembly as shown in Figure 1.
3. Cut tube on door at same location
4. Remove old grommet and tube assembly
5. Install new grommet and tube assembly making connection at bottom of recess (make sure connection is secure)
6. Check for leak
7. Replace recess

Note: If the original part is used for replacement it may continue to crack.
