Service Bulletin

REFRIGERATORS
Electronic Side-by-Side
Metal Liner Models

REF 11-03

DEFROST HEATER HARNESS NOT FULLY SEATED

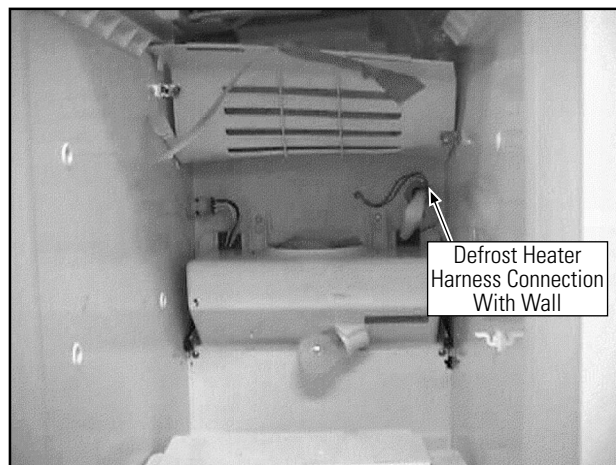
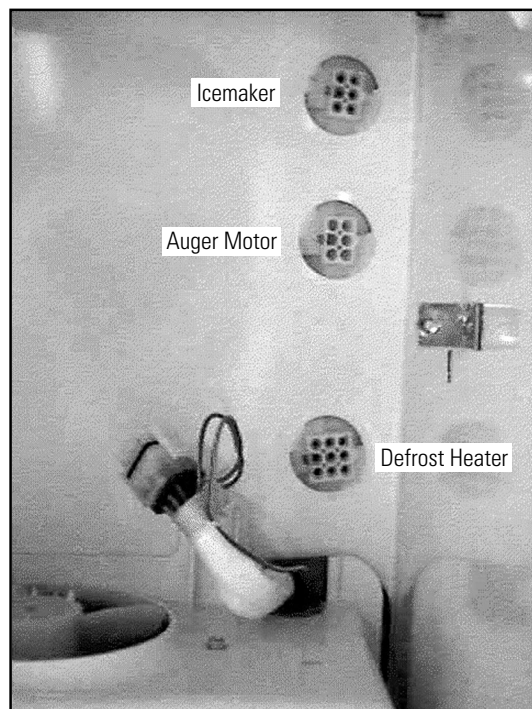
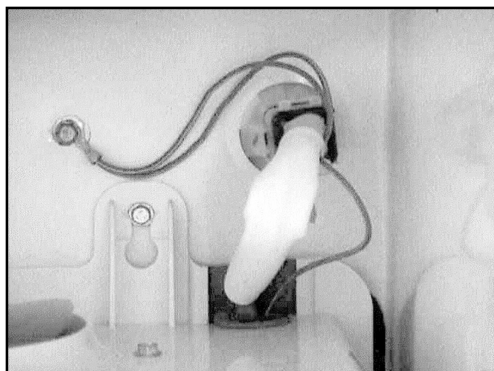
Consumers have reported icemakers not producing ice in the metal liner side-by-side models. In many cases the reason for this icemaker failure is due to the defrost heater harness not being fully seated, resulting in an intermittent connection. This issue has been seen in electronic side-by-side metal liner models with the serial number AA2 through ZD2.

This may be misdiagnosed as an open wire in the foamed-in AC case harness. During the investigation to find the root cause and verify continuity, some technicians are using an incorrect path for the orange neutral wire to the icemaker. For side-by-side metal liner models, the orange neutral path for the icemaker initially passes through the defrost heater harness, case side (rear wall) connector. A partially seated defrost heater harness (9-pin) will interrupt the circuit for the icemaker.

When servicing these models with reports of a non-functioning icemaker, make certain to check that the 9-pin defrost heater harness (coming out of the evaporator fan assembly) is fully seated and locked into the case side housing connector on the rear wall. For the best results, fully seat the harness and lock the tabs on the connectors one side at a time. Lock one side into place and use the body of the connector to leverage the other side into place. When this is completed, perform continuity check for the neutral between the 6-pin icemaker plug and the 9-pin defrost heater harness plug to verify continuity.
