Service Bulletin

General Electric Company Appliance Park, Louisville, KY 40225 GE MONOGRAM REFRIGERATORS REF 09-00 BOTTOM-MOUNT & SXS MODELS 1993 to CURRENT INTERMITTENT LIGHT & EVAPORATOR FAN SWITCH OPERATION

JUNE 2000

INTERMITTENT LIGHT AND EVAPORATOR FAN SWITCH OPERATION

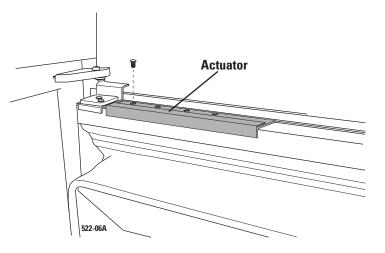
Fig. 1

Complaints listed below are likely to be the result of intermittent contact of the refrigerator doors with the light and evaporator switches in bottom-mount and side-by-side models.

The field correction part, actuator

WR02X10470 will correct the problem. You will need an actuator for fresh food and freezer doors.

- 1. To determine appropriate screw location, place actuator against hinge overlapping back edge of door.
- 2. Remove actuator and existing screw.
- 3. Remove release paper from back of actuator. Align actuator with proper screw hole and reinstall screw as shown in Figure 1. Press down on opposite end to ensure adhesion to door
