Service Bulletin

REF 02-01 REFRIGERATORS ZISW36DC ZISW42DC ZISW48DC ZISB36DC ZISB42DC ZISB48DC ZISS36DC ZISS42DC ZISS48DC ZIS36NC **ZIS48NC** ZIS42NC ZISS36NC ZISS42NC ZISS48NC **WATER SYSTEM DIAGRAM**

FEBRUARY 2001

Fill Tube Freezing Up

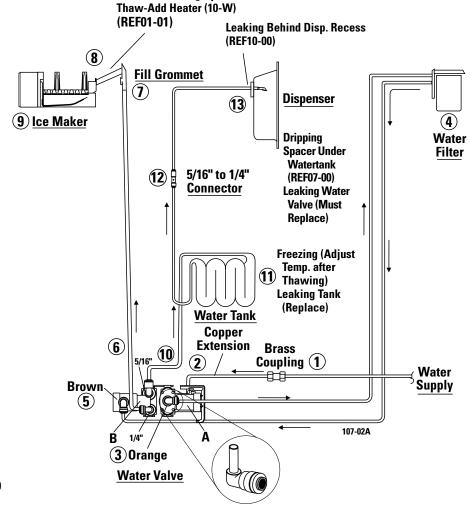
In February of 2000, a water filter was added to our Monogram side-by-side models. The following diagram will help to better identify leak locations.

- 1. Brass coupling
- 2. Copper extension
- 3. Elbow connector at water valve (orange)
 - a) leaking at valve
 - b) leaking at tubing
- 4. Water filter
- 5. Elbow connector at water valve (brown)
 - a) leaking at valve
 - b) leaking at tubing
- 6. Elbow connector at water valve (1/4")
 - a) leaking at valve
 - b) leaking at tubing
- 7. Plastic tube at fill grommet
- 8. Fill cup, fill tube
- 9. Icemaker
- Elbow connector at water valve (5/16")
 - a) leaking at valve
 - b) leaking at tubing
- 11. Water tank
- 12. 5/16" to 1/4" connector tank to door
- 13. Tube @ dispenser

Please message one of the following Product Quality Engineers with leak locations after repairs have been completed.
