SERVICE FLASH

## Poor Refrigeration Temperatures

# RF093

**MODEL/SERIAL #** 12 Cu. Ft. Top Mount FRT124 With Serial Numbers Beginning With RA

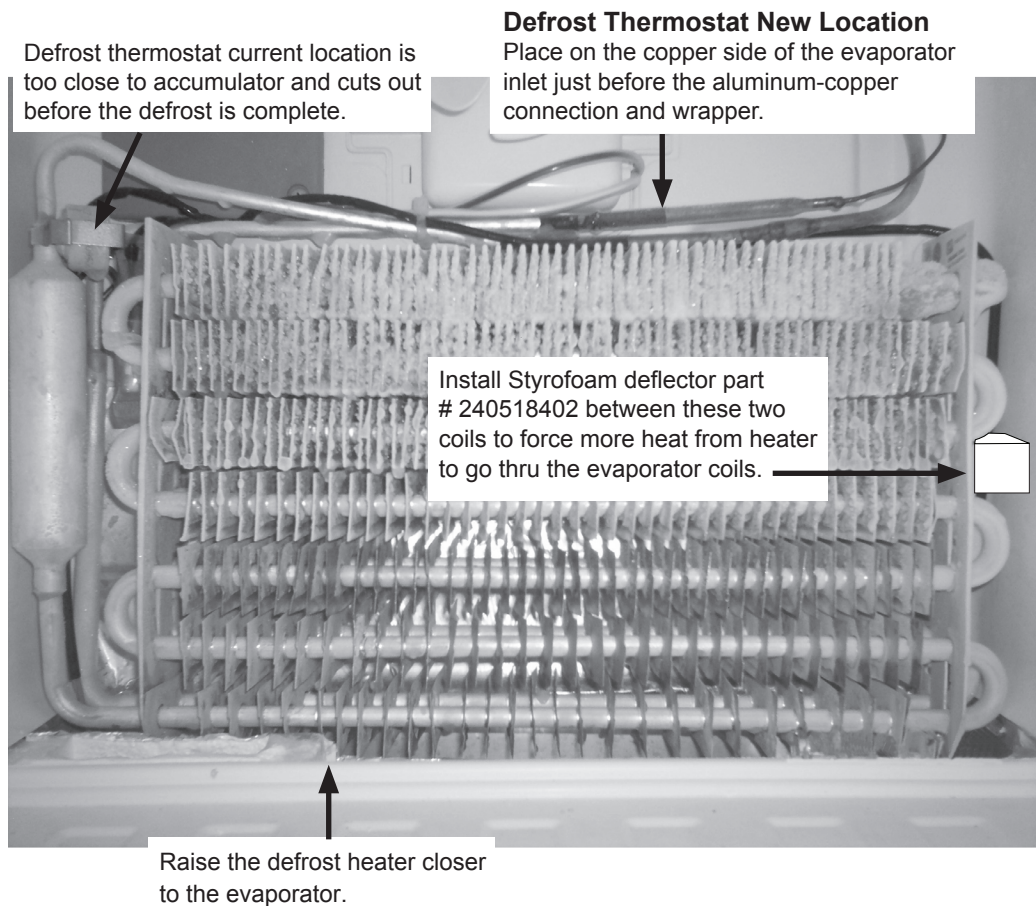
**PROBLEM** Frost build-up on Evaporator causing poor refrigeration temperatures

**CAUSE** Defrost Thermostat short cycling.

Please review the illustration for the defrost thermostat and Styrofoam block locations.

**SOLUTION** Replace and relocate the defrost thermostat, install air deflector and raise the heating element. Position the defrost thermostat at the location shown below.

1. The replacement thermostat is part # 401769-1010. Follow Steps 2 and 3 below.

1. The replacement thermostat is part # 5303917954.
2. Install Styrofoam deflector part # 240518402 (Cut to Fit) in order to deflect more heat from the defrost heater to the upper portion of the evaporator coil.
3. Raise-up the defrost heater closer to the evaporator to ensure a more direct heat source.
