SERVICE NOTE BOOK
ALL REFRIGERATOR MODELS
VUAR--VRBD--VUBD--VUWC

VIKING RANGE CORPORATION

VIKING RANGE ALL-REFRIGERATION MODELS

VUWC140/150—VUAR140/150—VRBD—VUBD

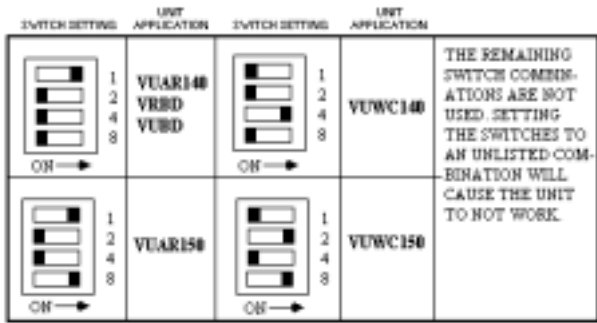
1. Before working on the unit unplug it first.
2. Using the Phillips screwdriver, remove the screws from the grille on the front of the unit.
3. Carefully pull the wires off of the old thermostat.
4. Unscrew the thermostat from the bracket.
5. Loosen the screw holding the thermobulb clamp on.
6. Gently remove the thermobulb away from clamp.
7. Go to rear of unit and gently pull the capillary tube from the thermostat out of the unit.
8. Set dip switches for the correct unit. (Ill # 1)
